# Peugeot 508 Sedan 2010-18

## PU Side Mouldings

### F-16

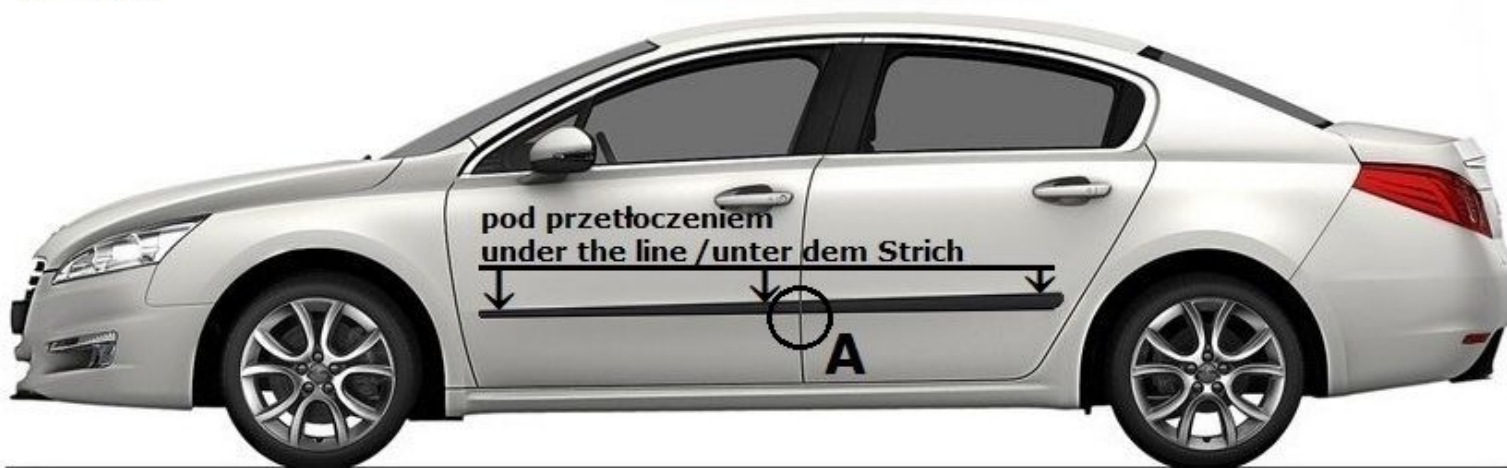
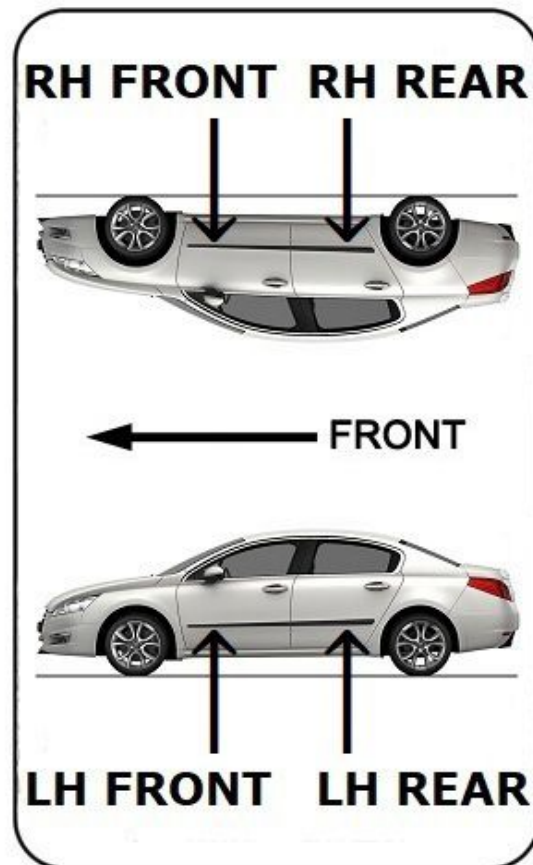
Degrease/entletten/degraisser/ontvetten  
Alcohol/Alkohol/Alcool/Alcohol

Diagram showing a hand cleaning the car's side panel with a cloth.

20-40 °C

Diagram showing a hand applying a strip of PU moulding to the car's side panel.

Diagram showing a hand using a utility knife to cut a strip of PU moulding.

Diagram showing a hand pressing the PU moulding onto the car's side panel.

Diagram showing a car with a '48h' drying period indicated by a clock icon and a crossed-out car icon.

ledere cm goed aandrukken !!  
Press very carefully every cm !!  
Sehr fest andrücken jeden cm !!
